September 10, 2012

Red Carpet Inn
3955 W. Colonial Drive
Orlando Florida 32808

Re: Red Carpet Inn
Fire Damage Structural Assessment

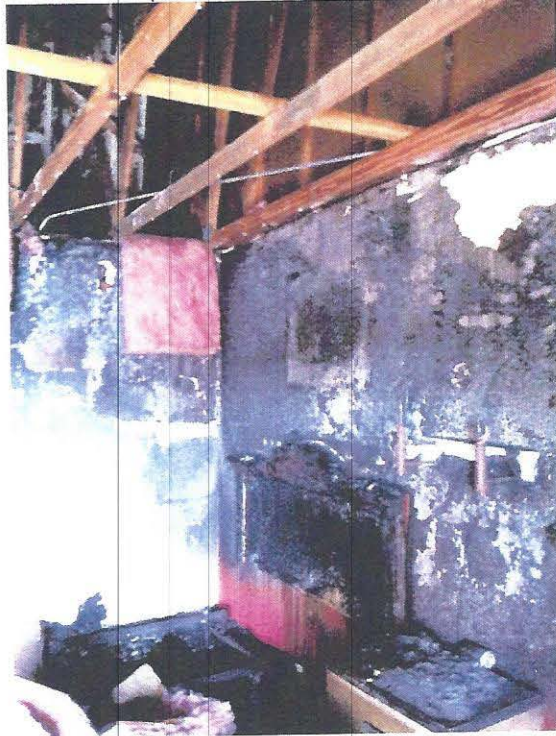
1. Apparently the fire incident took place on one of the hotel rooms located on the second floor without evidence for it spreading into adjacent rooms. (See Pictures – 3, 4 & 5).

2. Room Ceiling and walls observed completely charred (See Pictures – 3 & 4).
3. Room window metal framing observed damaged and bent out of shape (See Picture – 5).

Pictute-3 (Fire Damaged Room Interior)

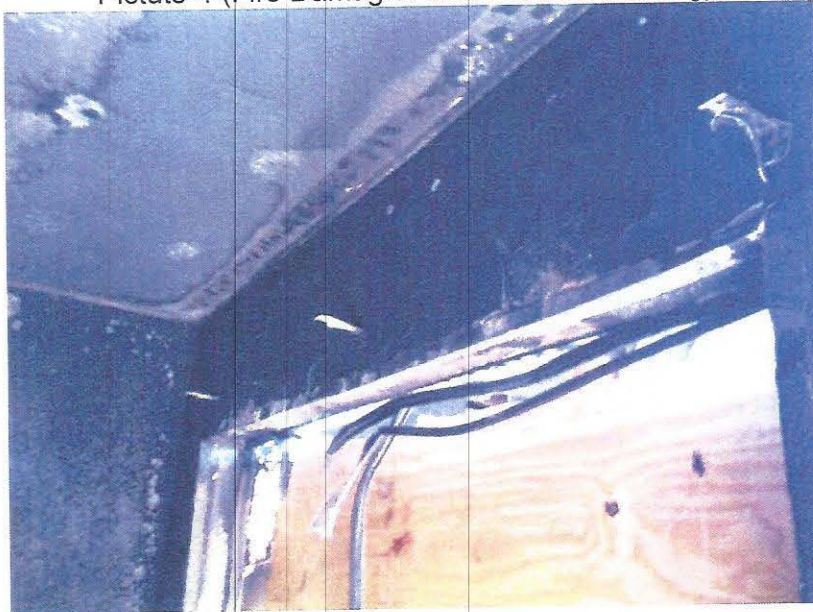
Pictute-4 (Fire Damaged room window framing)

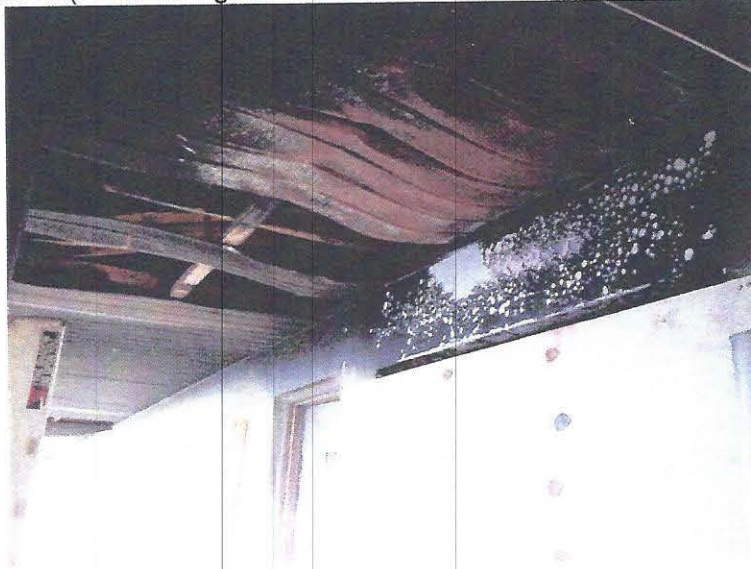
4. There is evidence observed of charred structural CMU lintel spanning over the window opening and evidence of charred bottom chord of the 6 wood trusses cantilevering of the structural CMU window opening lintel (See Pictures – 5 & 6).

5. Extreme temperatures during the fire incidence may have caused CMU lintel reinforcing bars to expand resulting in breaking the bond between reinforcing bars and the concrete grout infilling the CMU cores. Hence, ability of the CMU lintel extending over the wall openings within this area is significantly reduced.

Pictute-5 (Fire Damaged CMU Lintel Over Room Window Opening)

1. Remove and replace the 6 wood trusses, roof sheathing and roofing above the fire damaged room and replace with new per design and detailing of a professional structural engineer.
2. Repair CMU lintel and jambs above and around door and window openings of the fire damaged room per design and detailing of a professional structural engineer.

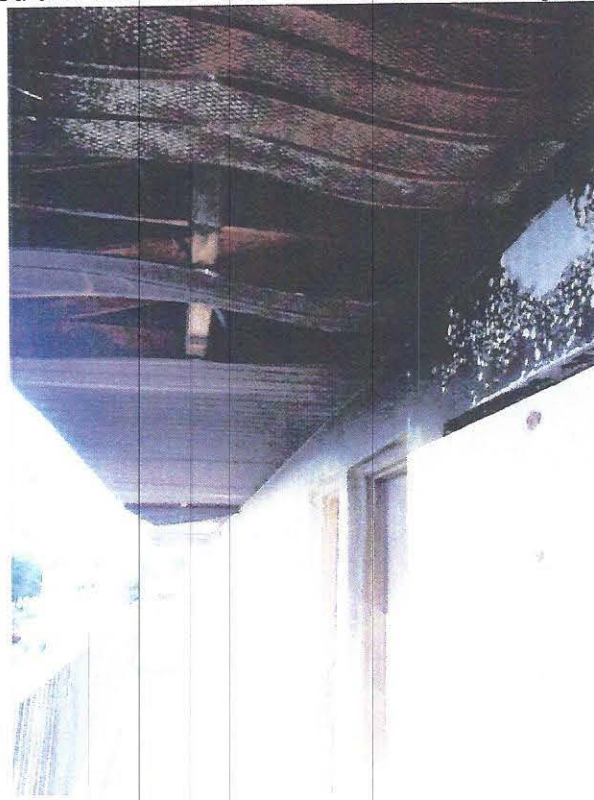
1. The temperature during the fire incidence in the damaged room could have very possibly reached 300 to 500 degrees Fahrenheit for a possible duration between 30 to 60 minutes. Hence and in accordance with the ASTM International (previously American society for Testing and Materials) Standard ASTM E 119 (1988), the 6 wood truss

members above the fire damaged room have experienced a great loss in its tensile strength.

Pictute-6 (Fire Damaged and Charred Roof Trusses cantilevering over CMU Window Lintel)

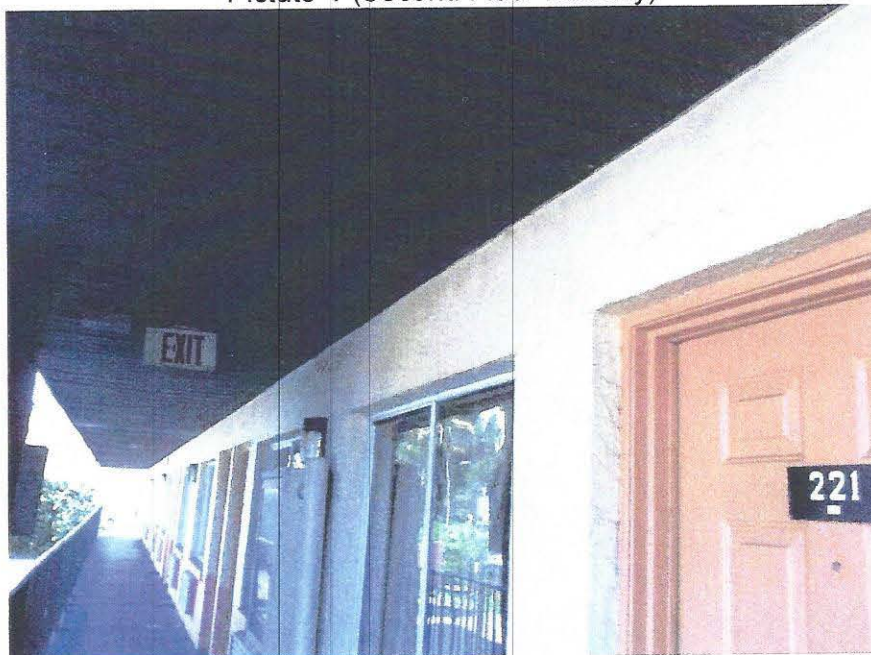
The roof framing system is composed of pre-engineered wood trusses, spaced approximately at 24" o.c., and a ply-wood sheathing roof diaphragm. The roof trusses are spanning across the width of the building supported by exterior load bearing Masonry Block walls at each end and two rows of interior load bearing wood stud walls separated by a service corridor along the middle of the building. The wood trusses are cantilevered over the masonry block wall to over hang over second floor balcony around the perimeter of the building (See Pictures - 1 & 2).

Pictute-1 (Second Floor Balcony)

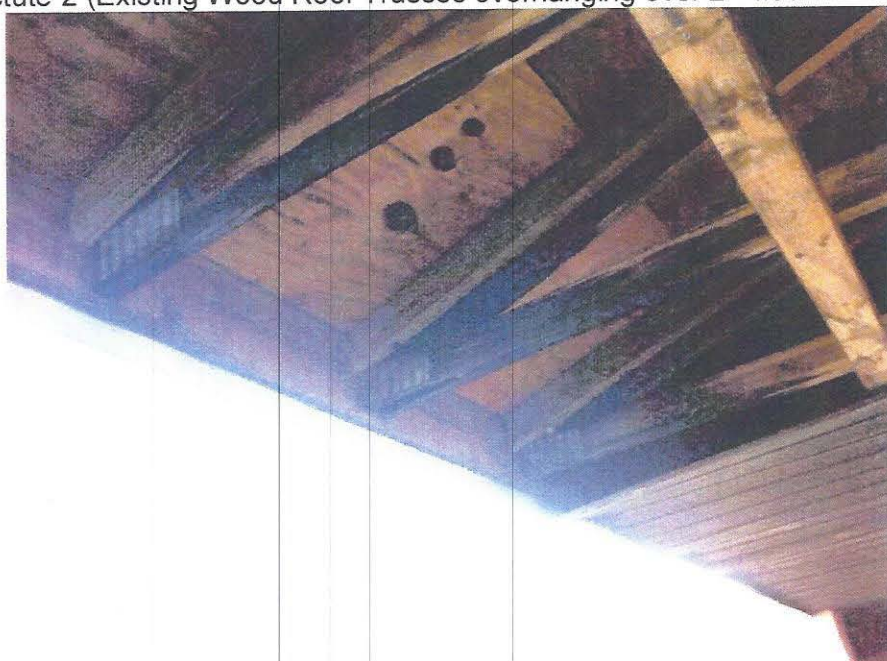
Pictute-2 (Existing Wood Roof Trusses overhanging over 2nd floor balcony)

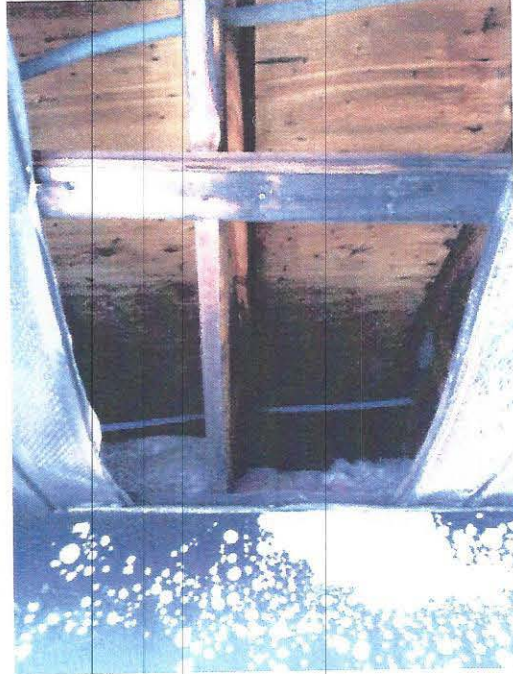
5. There is evidence of charred and twisting wood truss observed with damaged joint at truss end (See Pictures – 7 & 8).
6. Evidence of charred wood plate observed over window opening structural CMU lintel (See Picture – 9).

Picture-7 (Charred & Twisting wood truss)

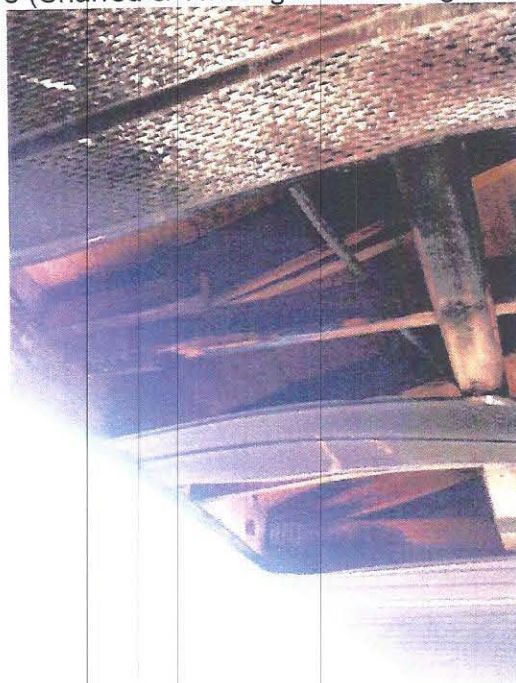
Picture-8 (Charred & Twisting truss damaged end joint)

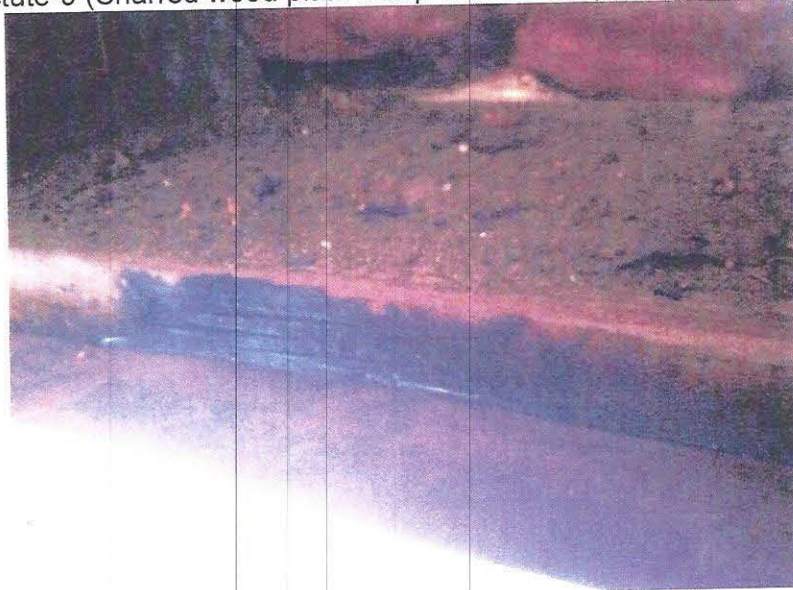
Pictute-9 (Charred wood plate at top of window opening CMU lintel)

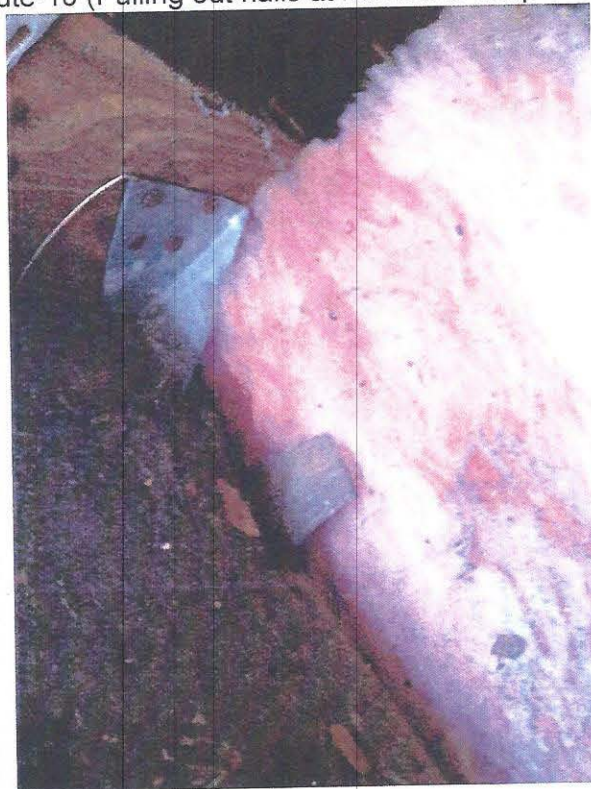
7. Evidence of pulling out nails observed at hurricane strap anchor (See Picture – 10).
8. For all 6 wood trusses over the fire damaged room, truss joints closest to the window and door openings observed separating and truss joint metal plates observed curling and pulling out (See Pictures – 11, 12, 13 & 14).

4. Pulling out nails along charred portion of the wood plate at trusses bearing on top of the load bearing exterior CMU wall above the door and window openings of the fire damaged room significantly reduces the ability of the roof framing within this area to resist wind up-lift pressures.

Pictute-10 (Pulling out nails at hurricane strap anchor)

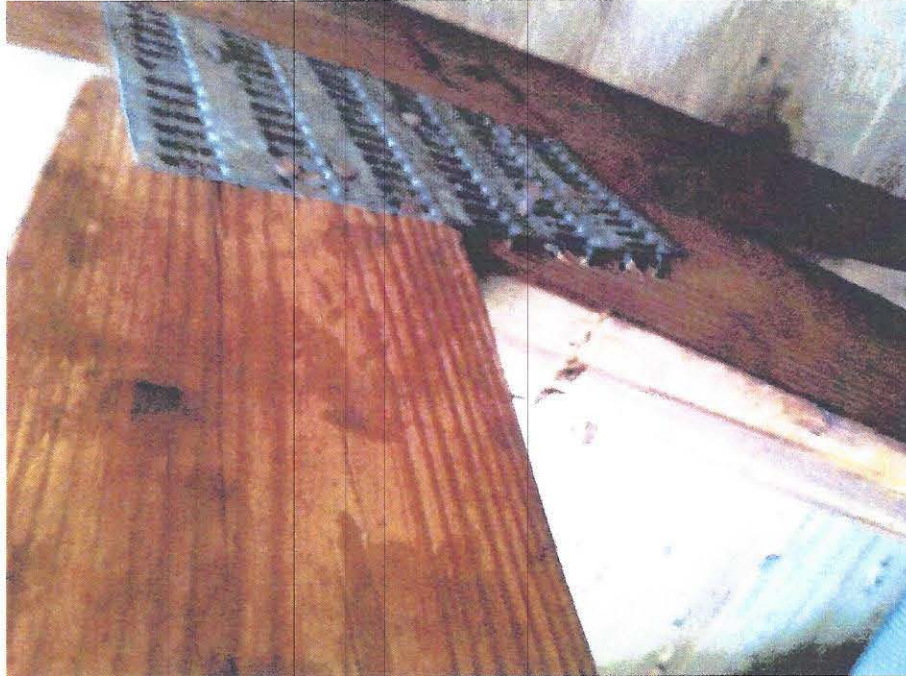
2. The 6 wood trusses above fire damaged room exhibiting joint separation and joint plates curling and pulling out are structurally not stable.
3. Portions of the roof plywood sheathing above the fire damaged room are not able to support roof gravity loads due to water damage. Further, roof sheathing damage within this area causes partial loss of the roof shear diaphragm structural integrity in distributing lateral loads in the CMU side shear walls.

Pictute-11 (Curling & pulling out Truss Joint Plate)

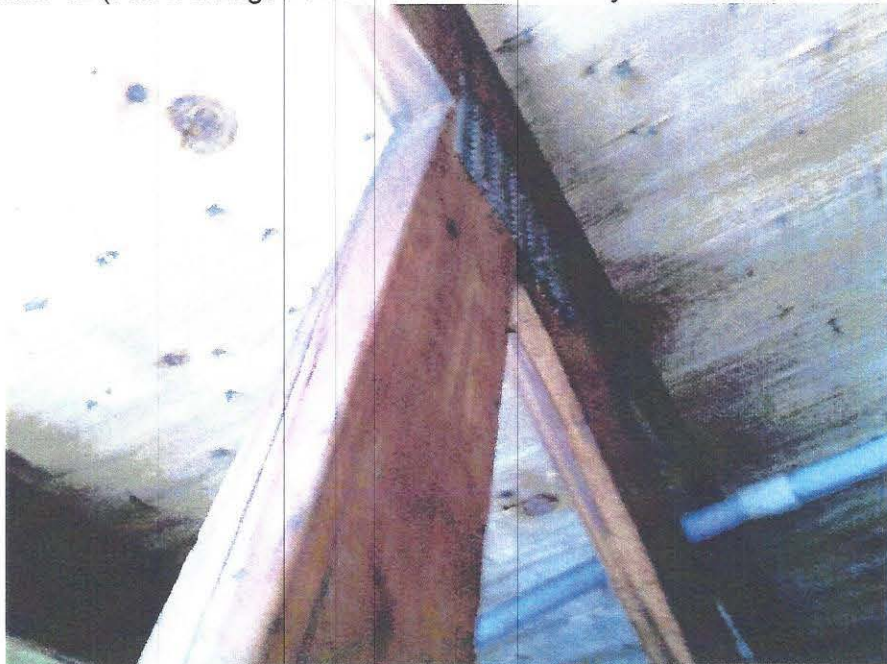
Pictute-12 (Fire Damaged above second floor entry stud walls & sheathing)

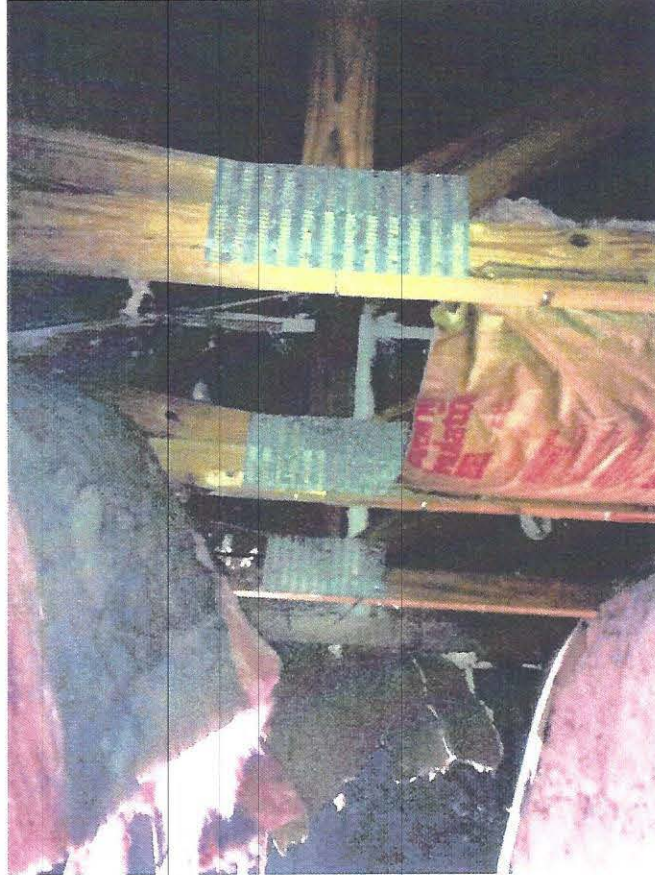
Pictute-13 (Separating Truss Joints at Metal Truss Plates)

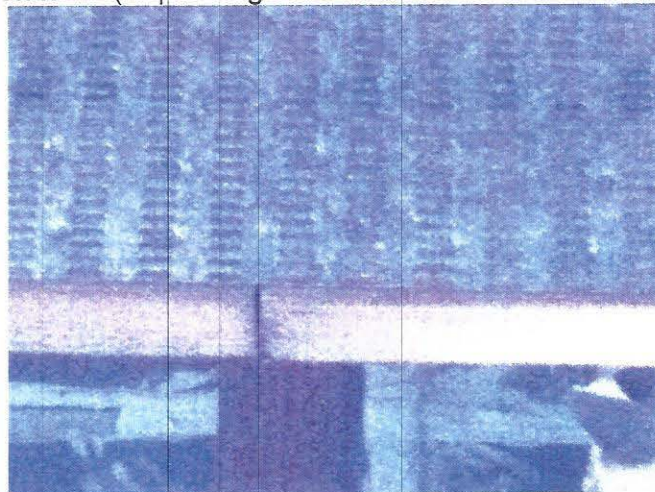
Pictute-14 (Separating Truss Joint at Truss Metal Plate)

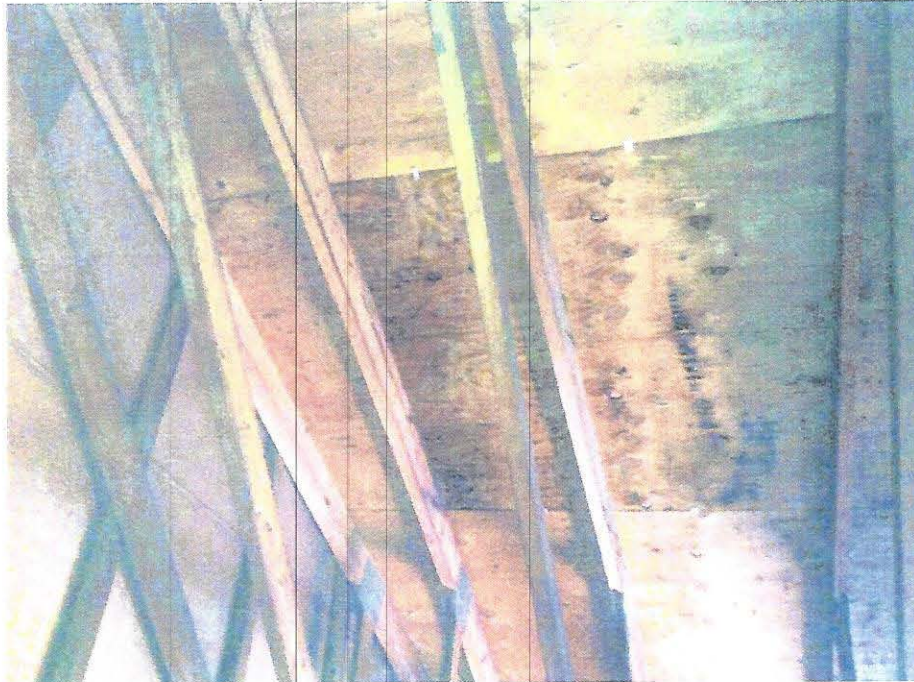
9. Evidence of water damaged roof plywood sheathing was observed within roof area located above fire damaged room (See Pictures – 15 & 16).

Pictute-15 (Water damage at roof plywood sheathing)

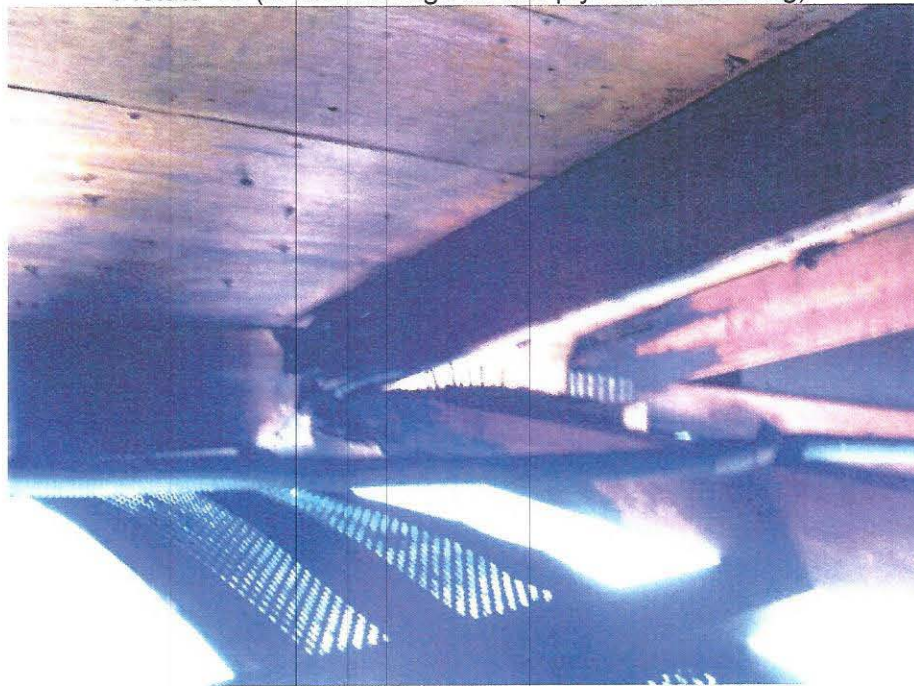
Pictute-16 (Water damage at roof plywood sheathing)
